Quest Engineering & Failure Analysis, Inc.
www.quest-engineering.com

Re: Rebuttal Report

File: Bryson Accident
Quest No: 10519

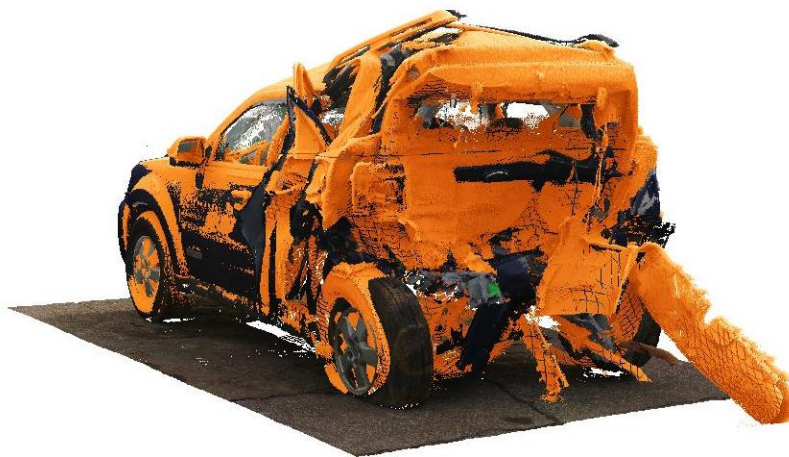
An analysis was performed to verify if there actually was more crush in the **test** than the **accident** Escape, as opined by Grimes (deposition page 210). The 3D scan of the **accident** Escape and the **test** Escape were overlaid using the undamaged front end of the vehicle. Then, cross sections of the both vehicles were taken at eight elevations and were compared. The analysis revealed that relative to the child location, there is more crush on the **accident** Escape at every elevation. *Figure 1* shows the **accident** Escape scan (black) and **test** Escape scan (orange) overlaid. Because the **test** Escape's orange color is more visible, it is more exposed and thus has less crush than the **accident** Escape.

*Figure 1: 3D overlay of the **accident** Escape (dark) and **test** Escape (orange)*

Further, the frame of the **accident** Escape (green tape identified) protrudes beyond the **test** vehicle, concretely demonstrating the override in the accident vs the non-override in the test. Directly behind the rear seat occupant's position, the test had 9 inches less crush.
